TEST REPORT No. CTI-PA 3017-1

Applicant: SCHIRTEC AG
Ignaz-Köck-Straße 10
1210 Wien

Type of test item: Air terminal, Model: S-AM

Selective tests according to EN 50164-1:2008, clause 6.3 Electrical test / Classification H

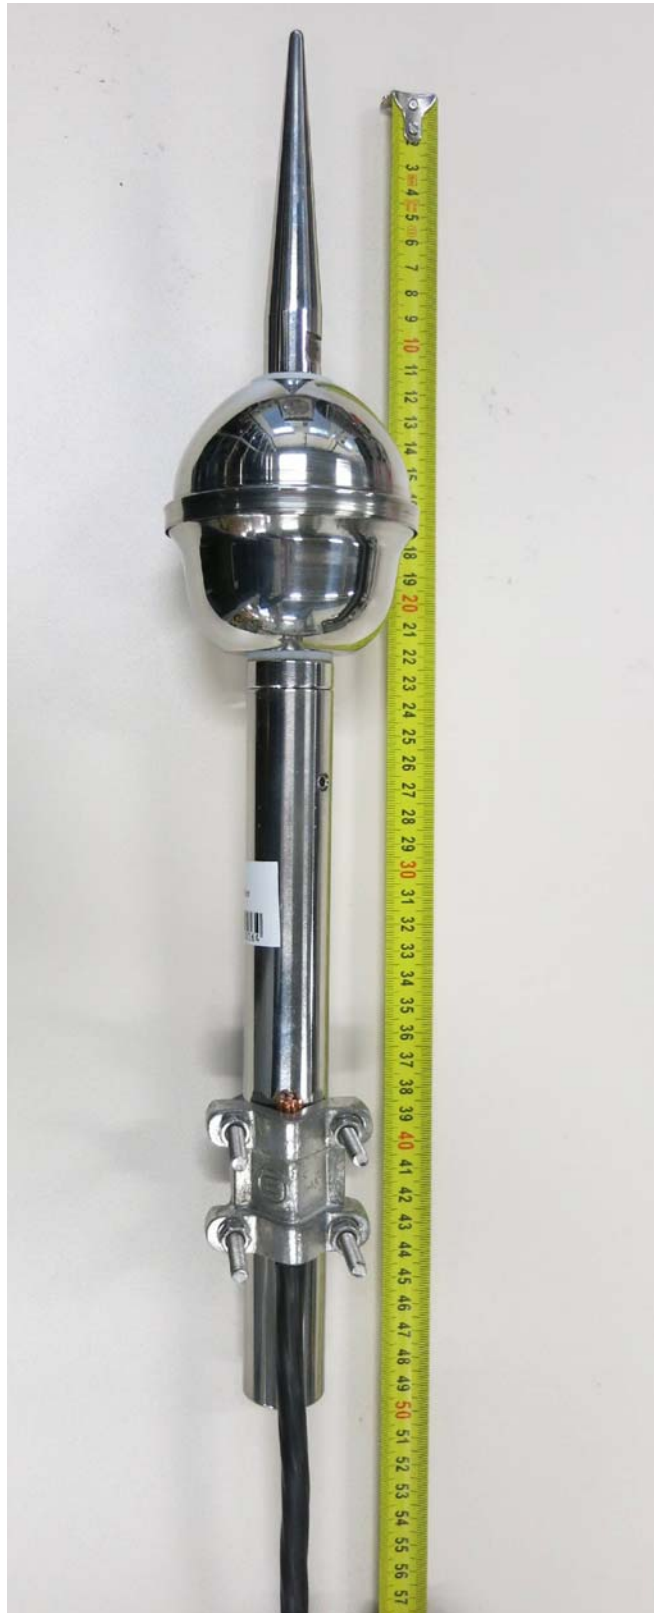
ANNEX 1

Test sample before the tests.

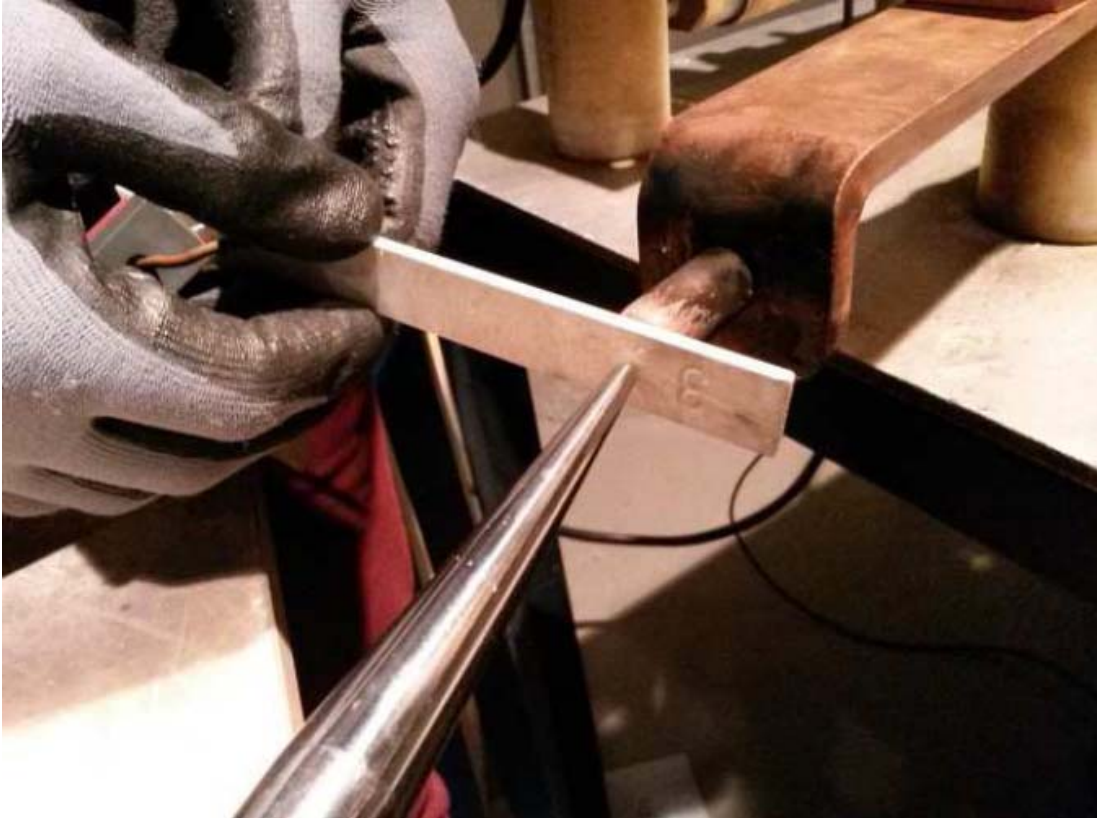
3mm arc gap to generator

The air terminal tip was connected via a minimum air gap of approx. 3mm to the other output terminal of the generator.

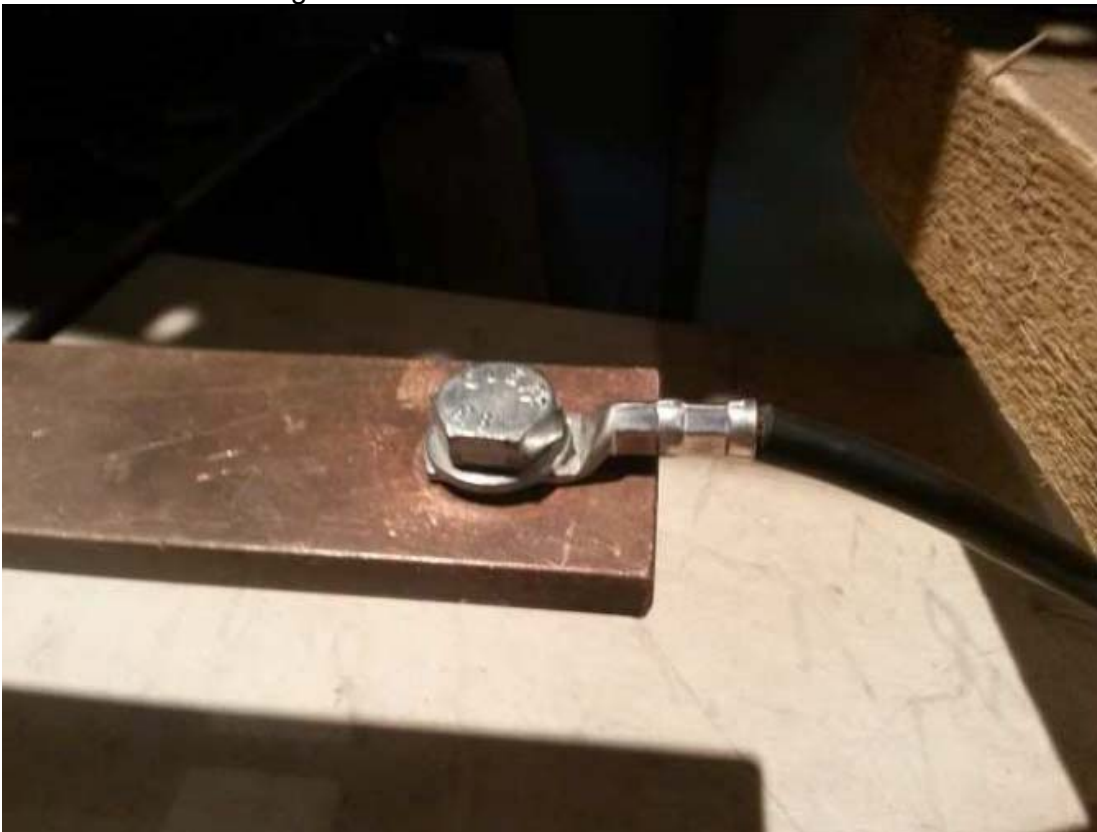
Ground connection to generator

The air terminal bottom tube was connected via a short down-conductor of appropriate cross section to the impulse generator. The connection between air terminal and down-conductor was done by use of a special clamping unit provided by the manufacturer.

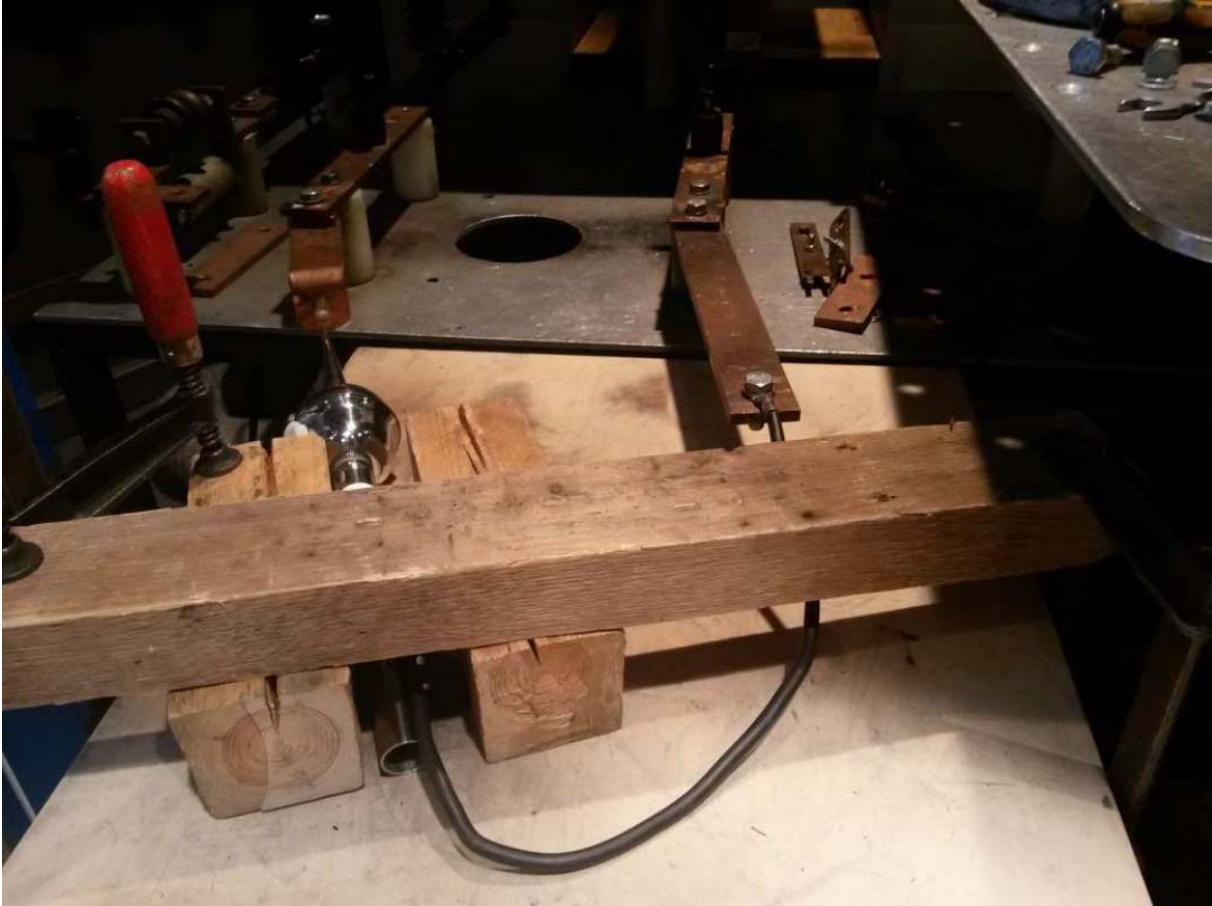
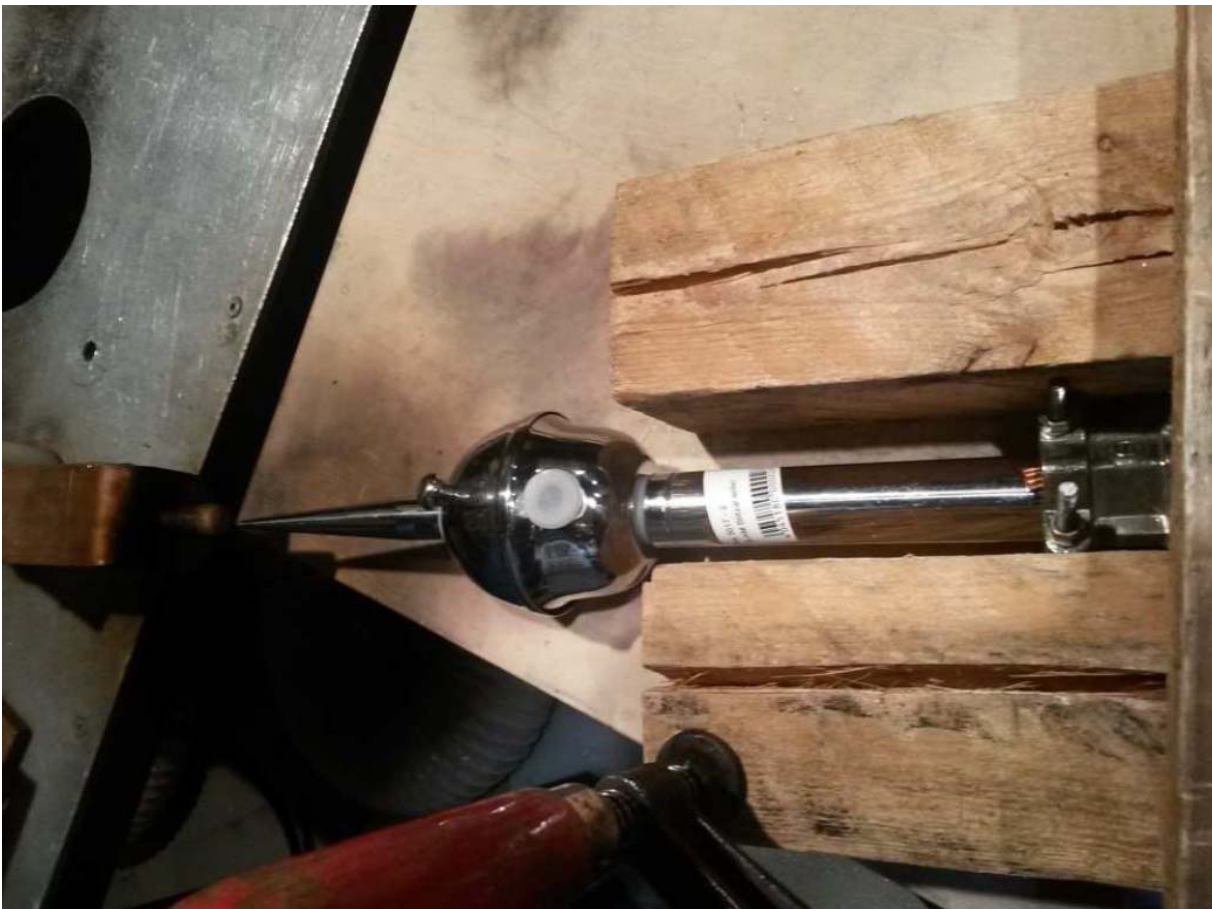
Sample connected to generator

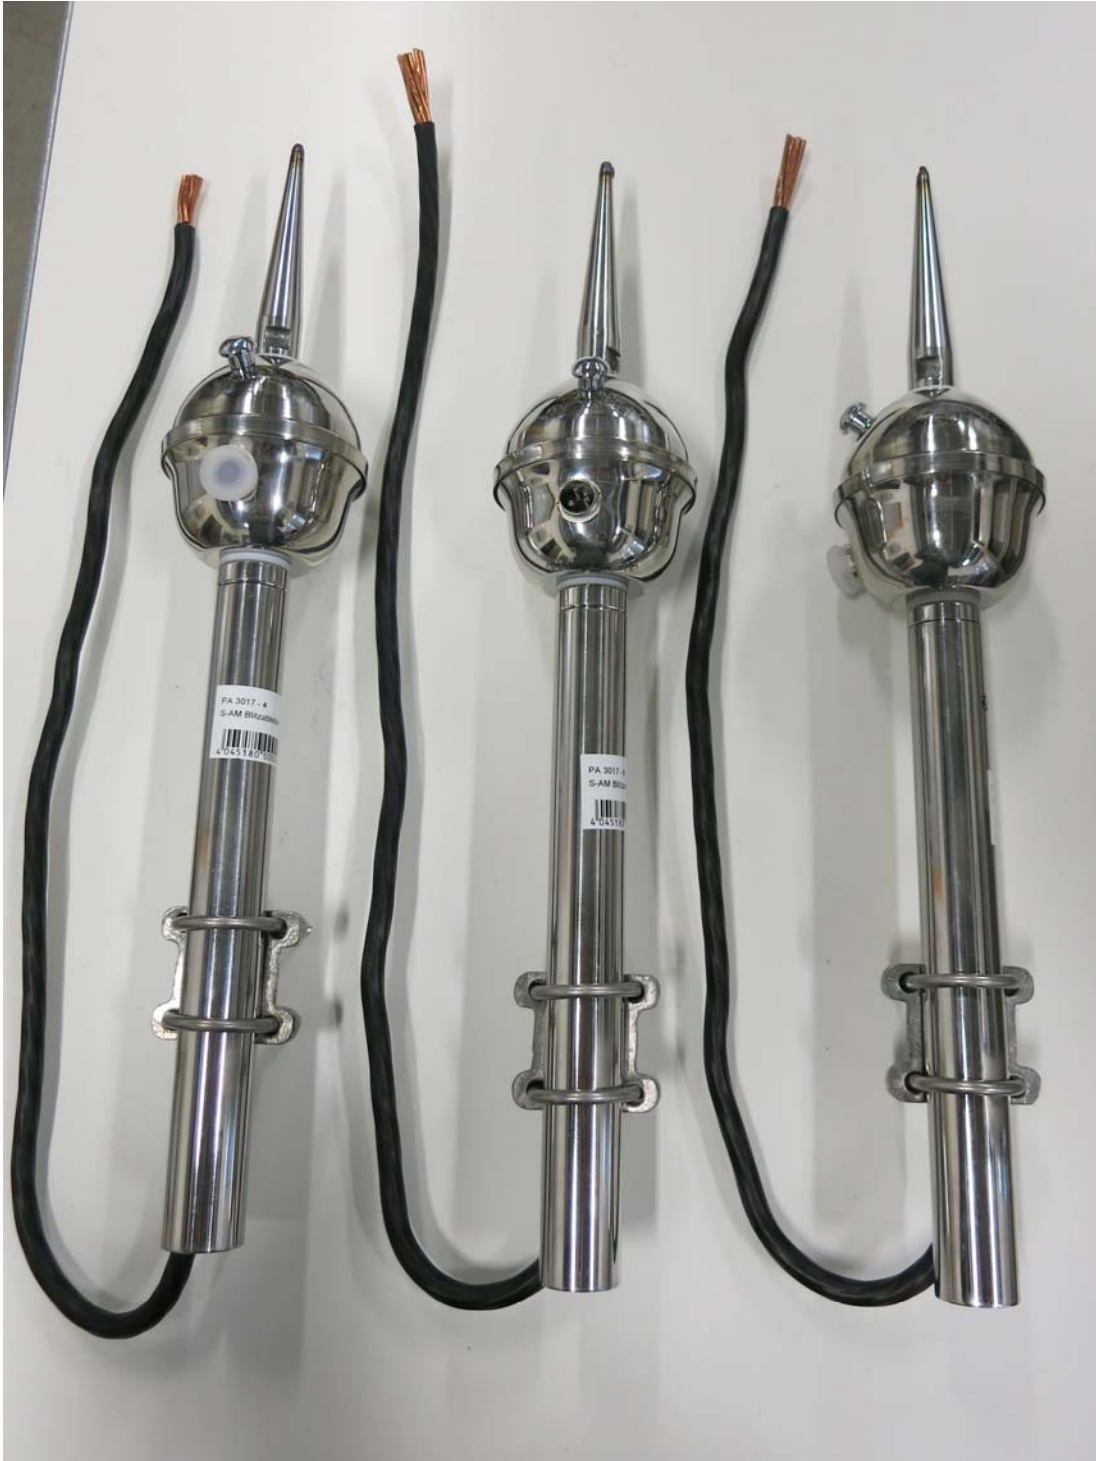
ANNEX 3

Test samples after the tests:

Tips of test samples showed discoloration and current marks due to arc.

Visual inspection showed discoloration of tips and current marks due to arc, but no physical damage, no loose parts and no deformation. Photos of the test samples after application of impulses are shown in ANNEX 3.

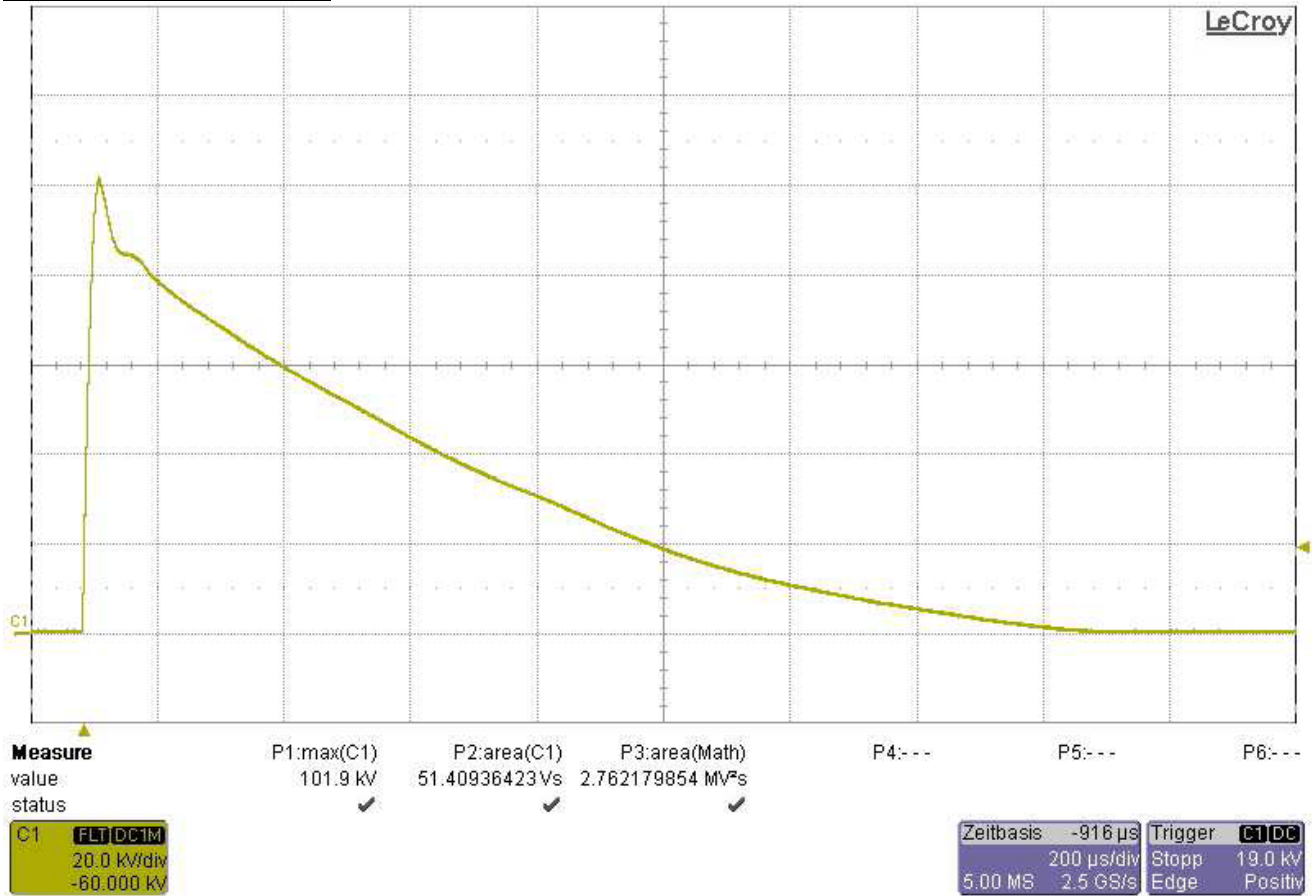
Sample 1, First impulse

$I_{imp} = 101,9kA, Q = 51,4As, W/R = 2,76MJ/\Omega$

I_{imp} [kA]	Q [As]	W/R [MJ/ Ω]
Sample 1			
First. Impulse	101,9	51,4	2,76
Second Impulse	101,5	47,4	2,45
Third Impulse	103,8	48,2	2,59
Sample 2			
First Impulse	102,2	50	2,63
Second Impulse	101,5	51	2,68
Third Impulse	104	50	2,69
Sample 3			
First Impulse	104,2	52,6	2,8
Second Impulse	101,8	51,6	2,71
Third Impulse	104,2	51,7	2,79

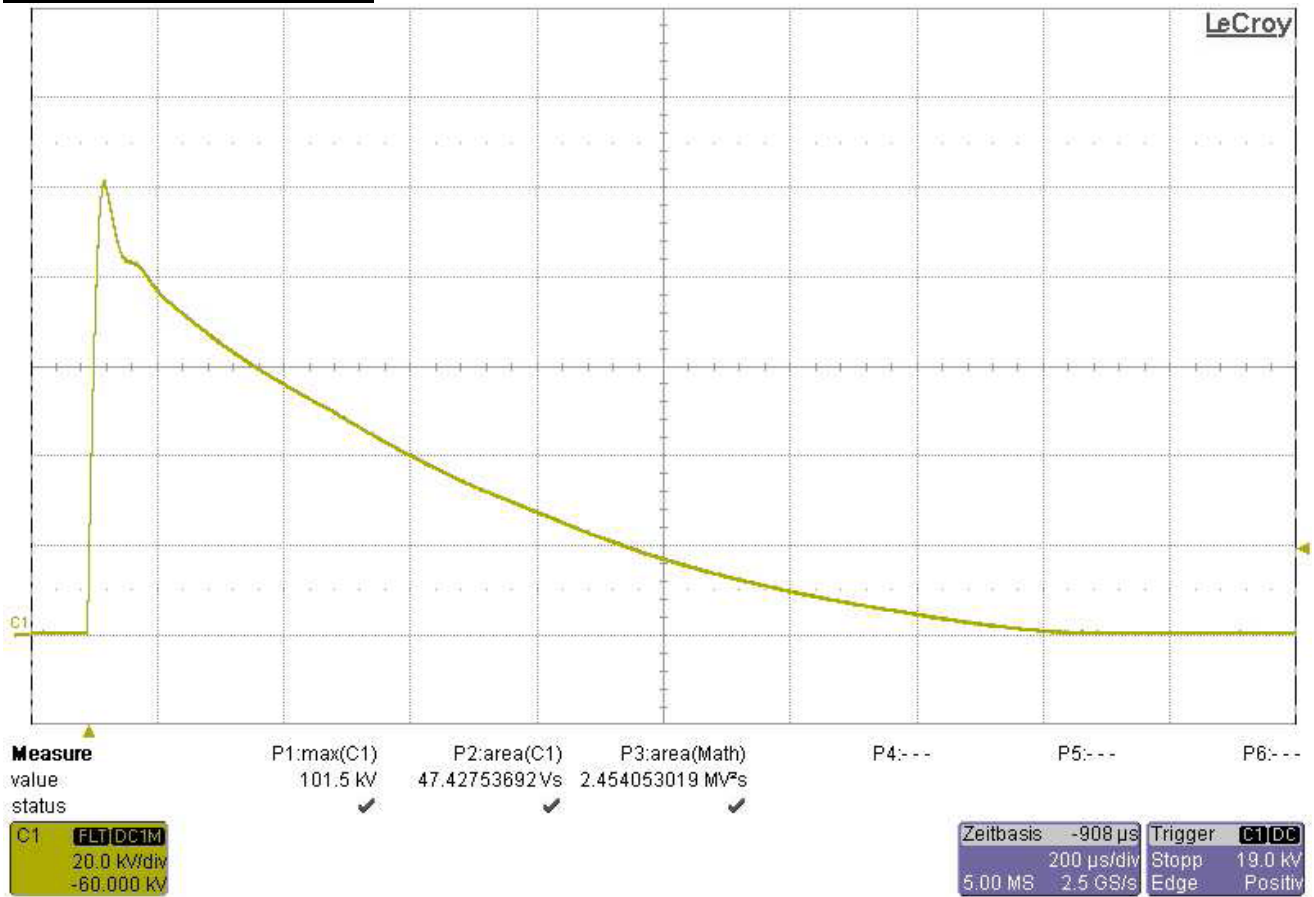
Sample 1, Second impulse

$I_{imp} = 101,5kA, Q = 47,4As, W/R = 2,45MJ/\Omega$

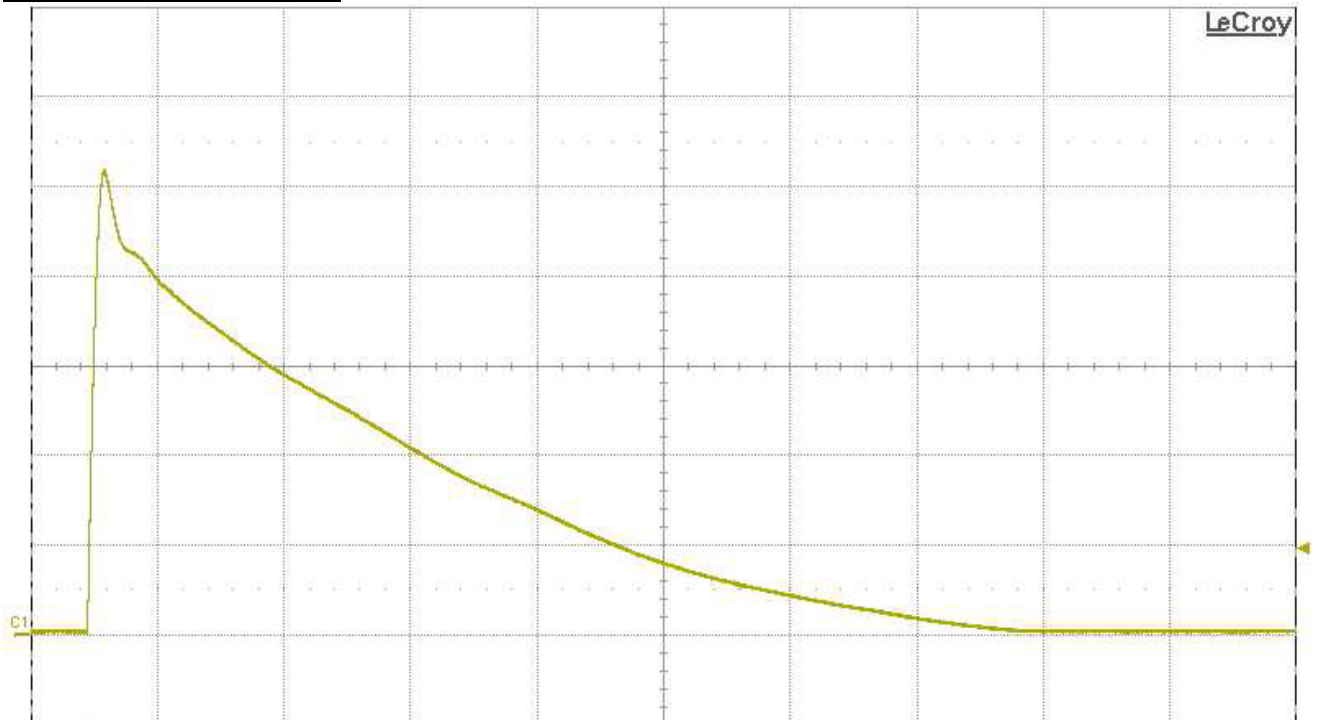
Sample 1, Third impulse

Measure	P1:max(C1)	P2:area(C1)	P3:area(Math)	P4:---	P5:---	P6:---
value:	103.8 kV	48.16565865 Vs	2.593477057 MV ² s			
status:	✓	✓	✓

$I_{imp} = 103,8\text{kA}$, $Q = 48,2\text{As}$, $W/R = 2,59\text{MJ}/\Omega$

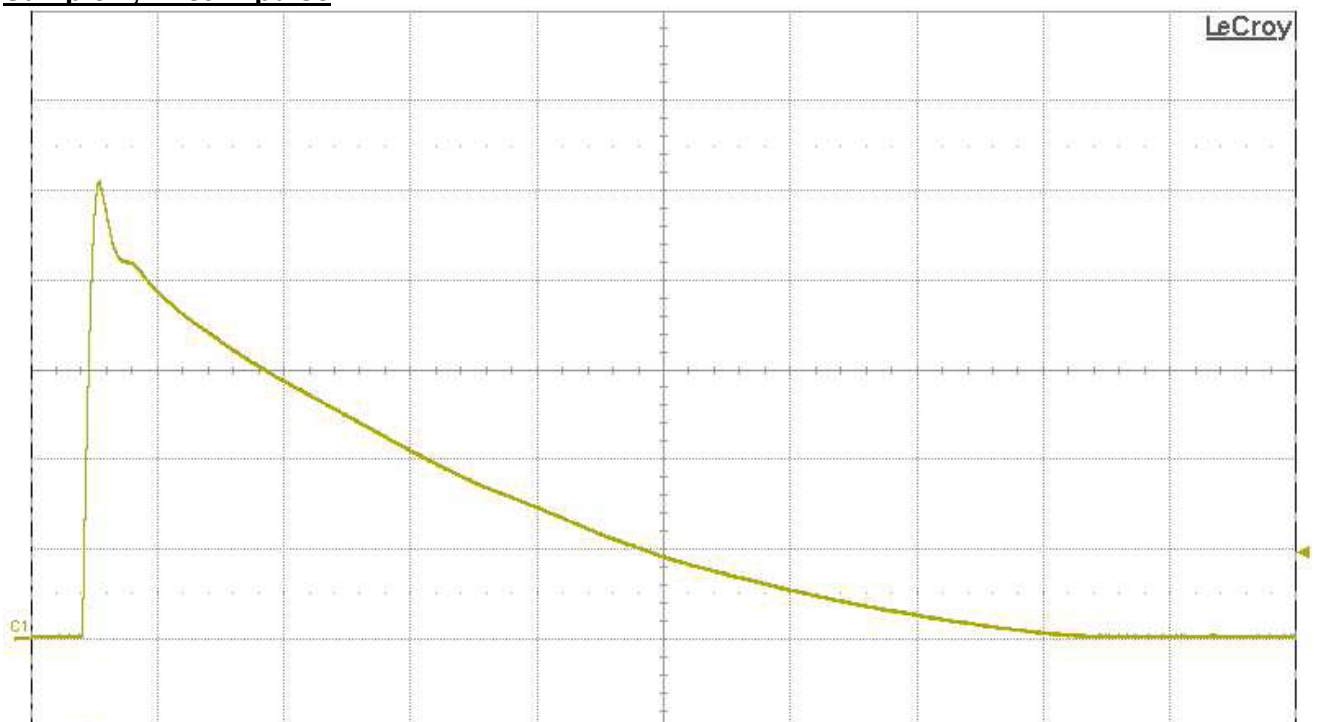
Sample 2, First impulse

Measure	P1:max(C1)	P2:area(C1)	P3:area(Math)	P4:---	P5:---	P6:---
value:	102.2 kV	49.95968950 Vs	2.630297589 MV ² s			
status:	✓	✓	✓

$I_{imp} = 102,2\text{kA}$, $Q = 50\text{As}$, $W/R = 2,63\text{MJ}/\Omega$

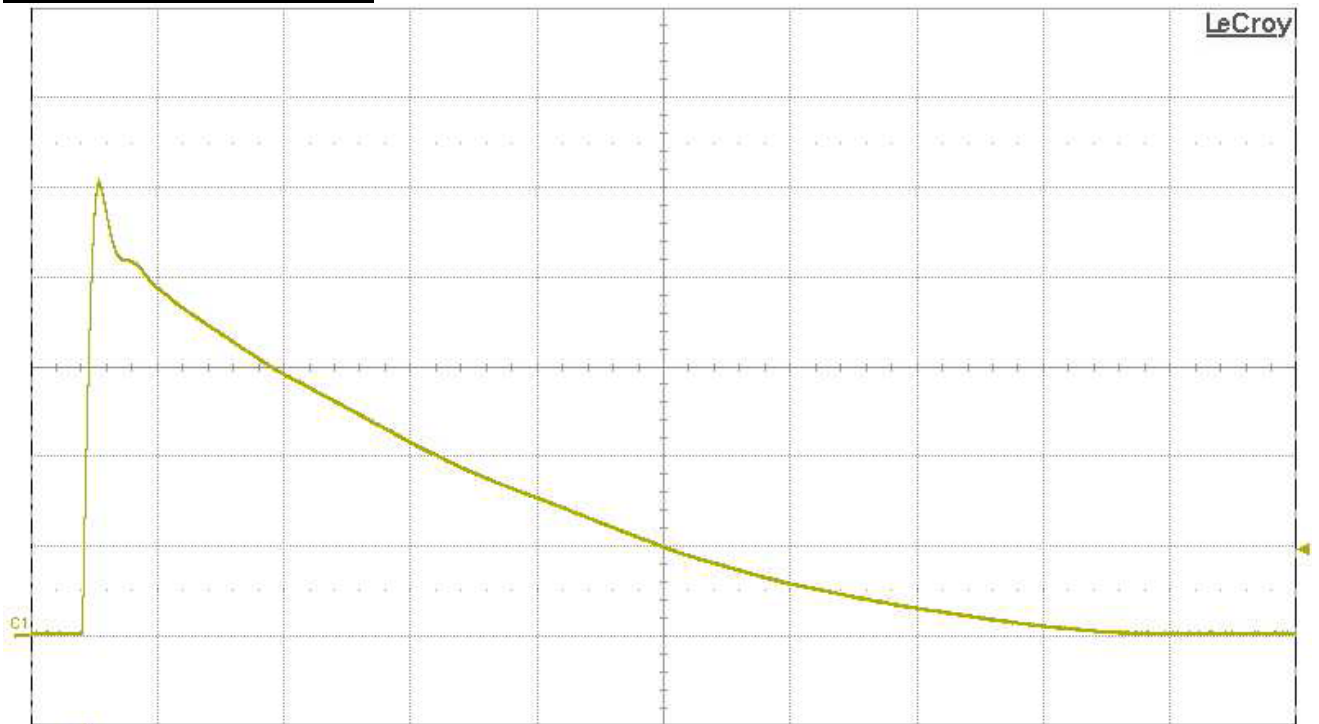
Sample 3, Second impulse

Measure	P1:max(C1)	P2:area(C1)	P3:area(Math)	P4:---	P5:---	P6:---
value:	101.8 kV	51.56879258 Vs	2.714972674 MV ² s			
status:	✓	✓	✓

$I_{imp} = 101,8\text{kA}$, $Q = 51,6\text{As}$, $W/R = 2,71\text{MJ}/\Omega$
